Turkish Chamber of Civil Engineers

**PRE-ASSESSMENT REPORT
ON
FEBRUARY 6, 2023
KAHRAMANMARAŞ PAZARCIK
AND ELBISTAN EARTHQUAKES**

14 February 2023

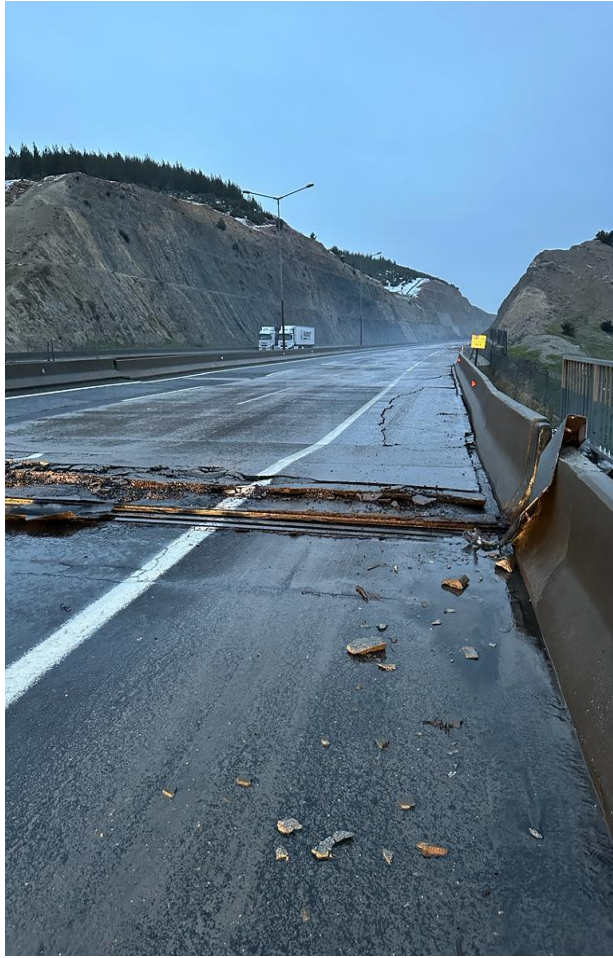
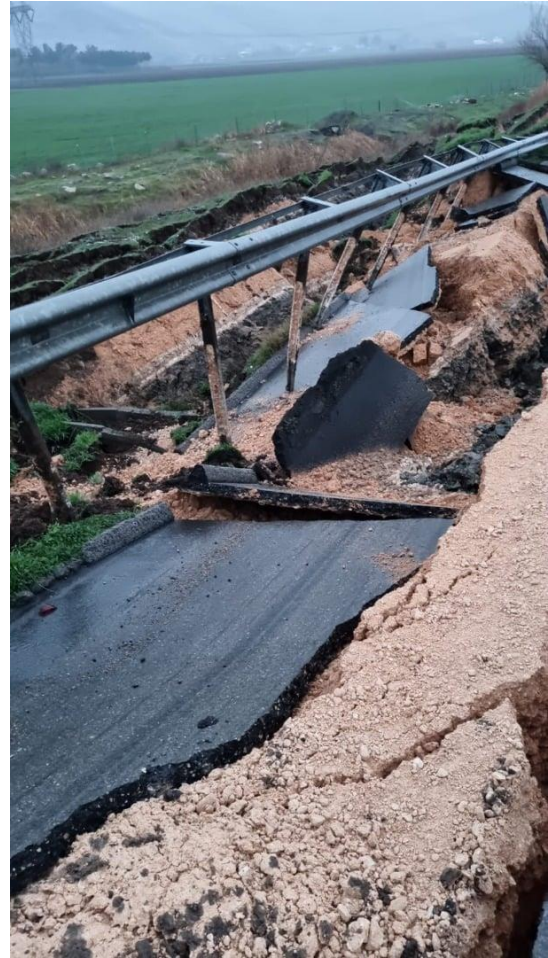
Photograph 5 - Highway of Gaziantep - Osmaniye

Osmaniye-Gaziantep direction was completely closed to traffic.

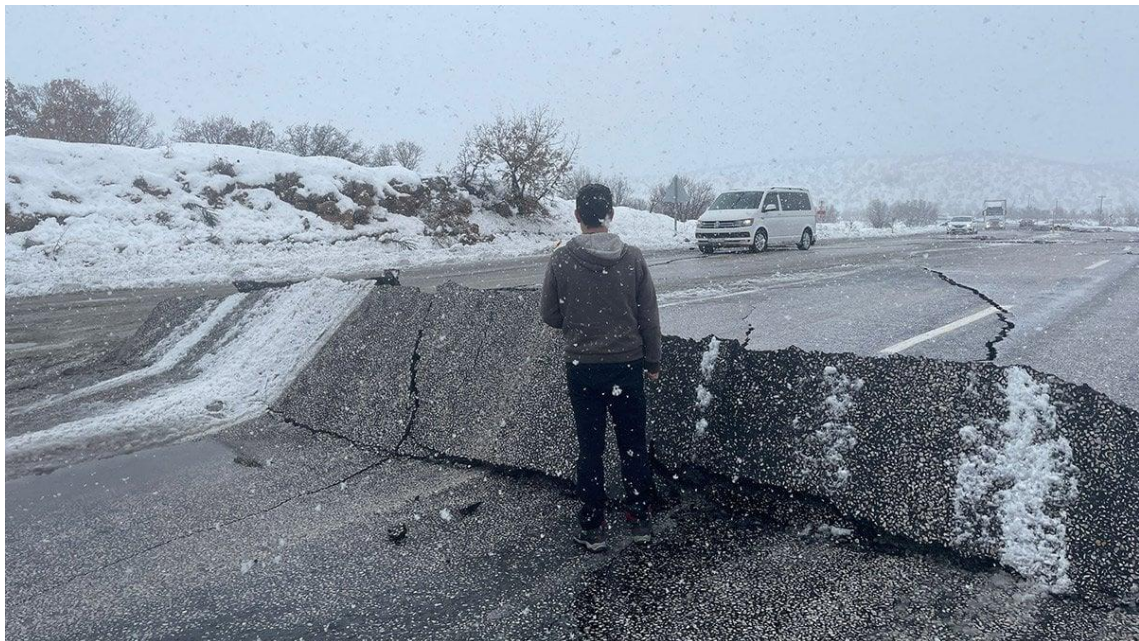
Photograph 6 - Highway of Malatya - Adiyaman

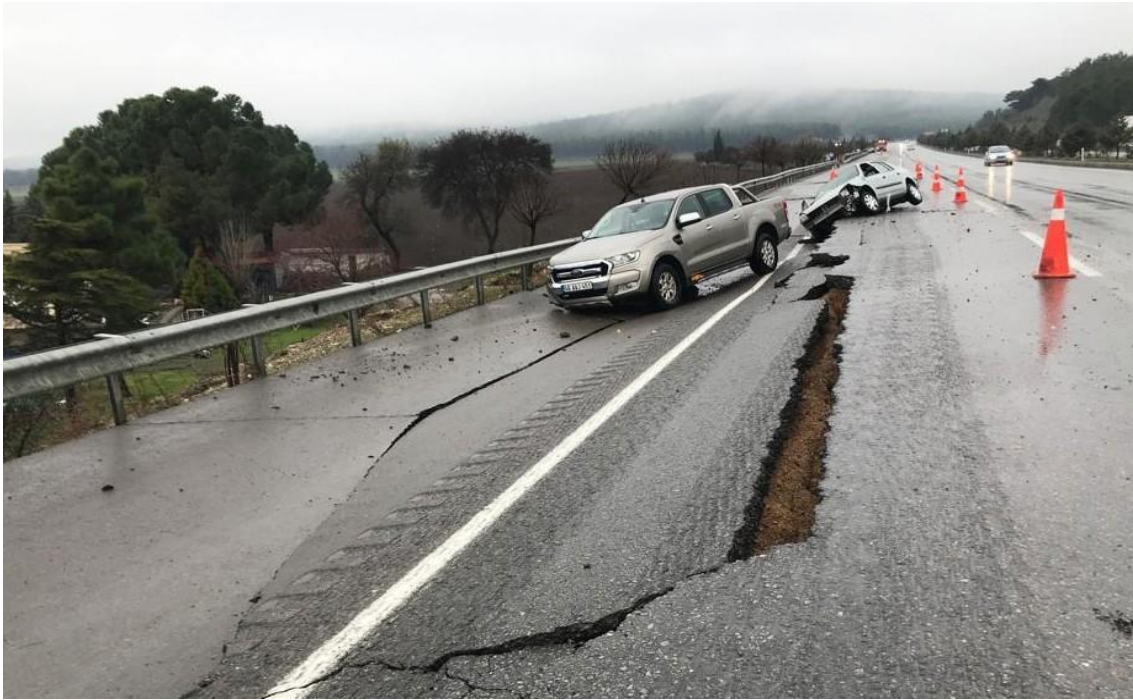
Photograph 7 - Highway of Kahramanmaraş - Pazarcık

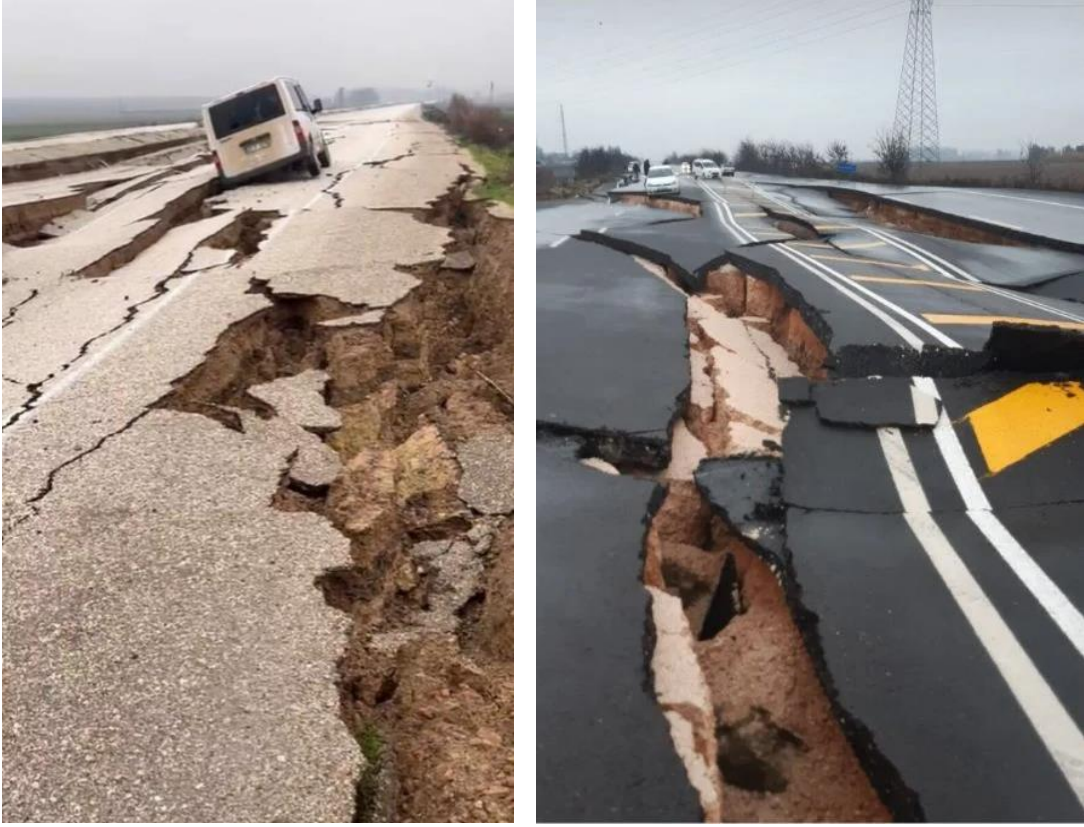
The Highway between Hatay Kırıkhan and Belen was closed to transportation due to a collapse.

Photograph 8 - Highway of Hatay - Kırıkhan and Highway of Kırıkhan - Reyhanlı

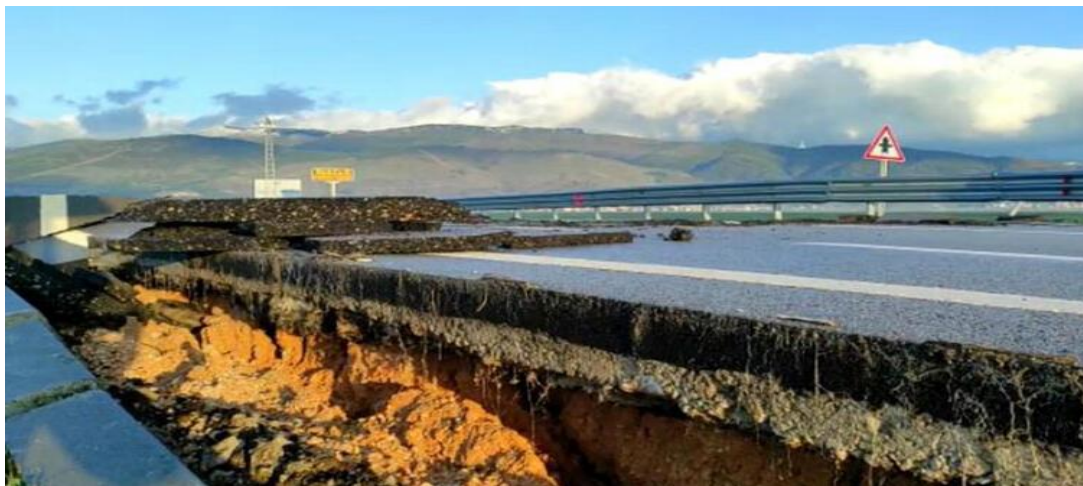
Photograph 10 - Hatay Airport Runway– 1

Kahramanmaraş and Hatay Airports were closed to flights due to damage.

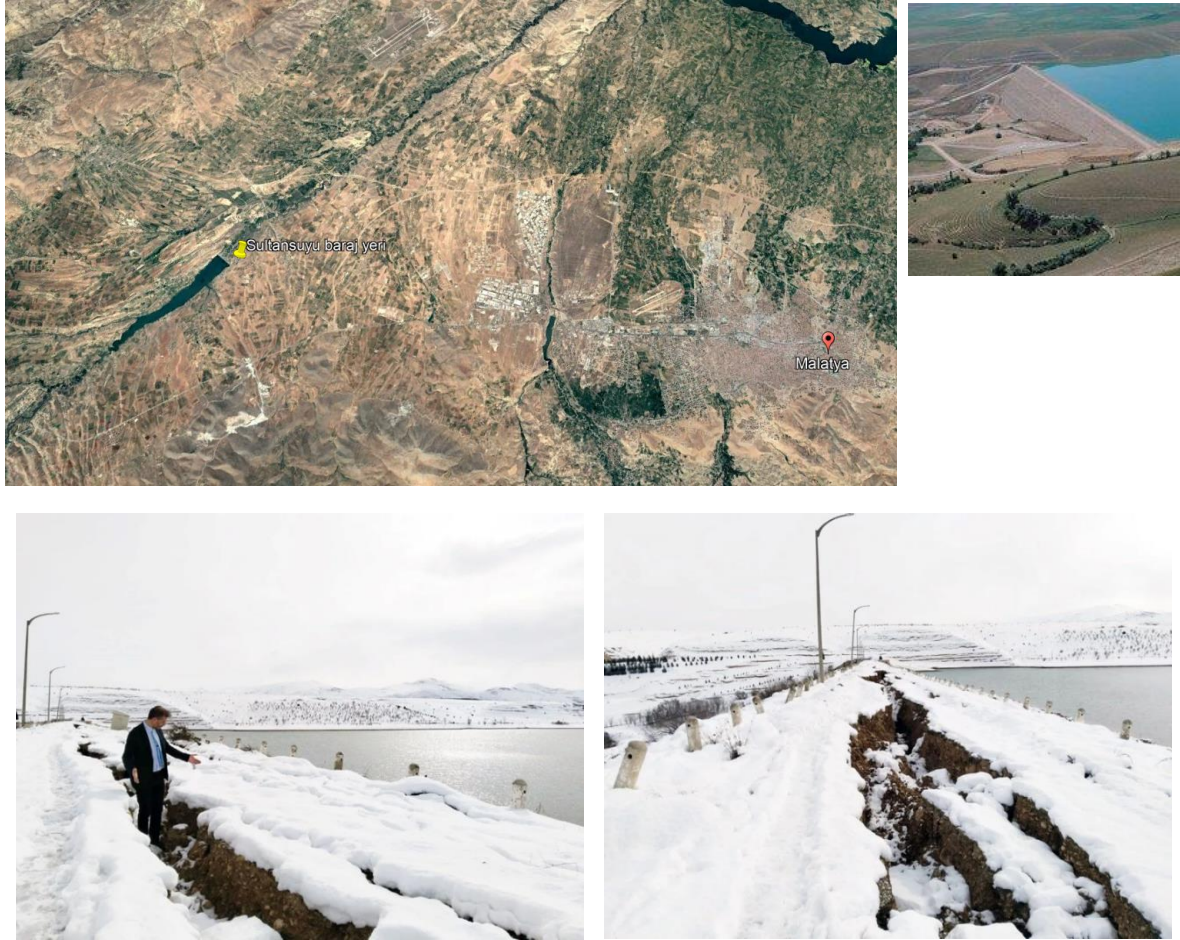
Photograph 13 – Sultansuyu Dam

According to the information received from the open sources, the water storage structures in the region were examined after the earthquakes on February 6, 2023 and it was declared that the Sultansuyu Dam in Malatya would be emptied as a precautionary measure due to the cracks in the dam body.

Sultansuyu Dam, designed for irrigation purposes, was built on the Sultansuyu River in Malatya. A total of 1,350,000 m³ of excavation and 3,200,000 m³ of fill production were carried out during the construction of the dam, which was built as an earth fill type. The body height of the dam is 60 m (from the foundation) and its length is 721 m. The diversion tunnel is 397 m long and 4.5 m in diameter.
