Turkish Chamber of Civil Engineers

**PRE-ASSESSMENT REPORT
ON
FEBRUARY 6, 2023
KAHRAMANMARAŞ PAZARCIK
AND ELBISTAN EARTHQUAKES**

14 February 2023

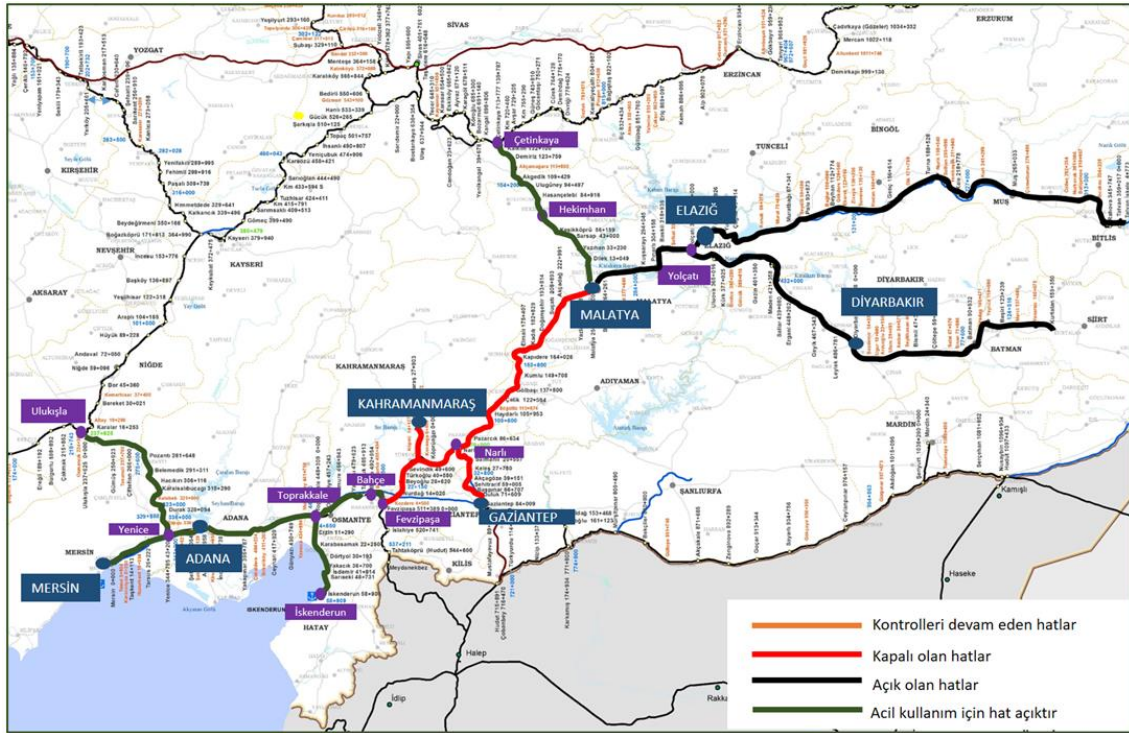
On February 11, 2023, The General Manager of the State Railways announced that the 1,275-kilometer line was damaged in the earthquake. In addition, he stated that maintenance was carried out in a thousand-kilometer area, while work continues in other regions.

Image 9 – Turkish Railways Open & Closed Status
